WATER OPERATION AND MAINTENANCE

BULLETIN NO. 112

JUNE 1980

TRAVELING WATER SCREEN DRAINLINE'

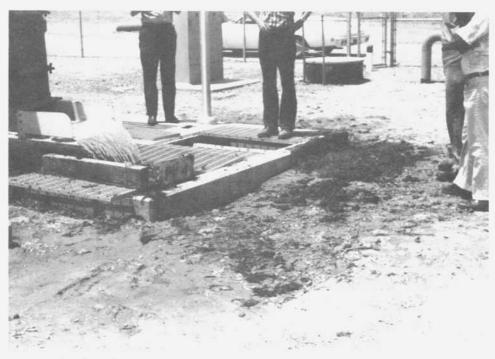
Figure 1. Traveling water screen assembly at far left and wash water and moss entering sump drain. Note debris removed from stationary screens and saturated yard.

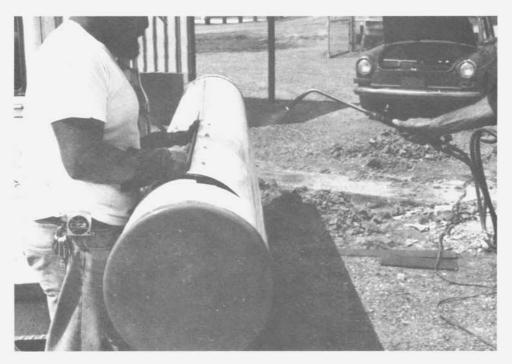
Figure 4. Applying heat to 380-mm (15-in) PVC pipe to allow forming a trough without cracking

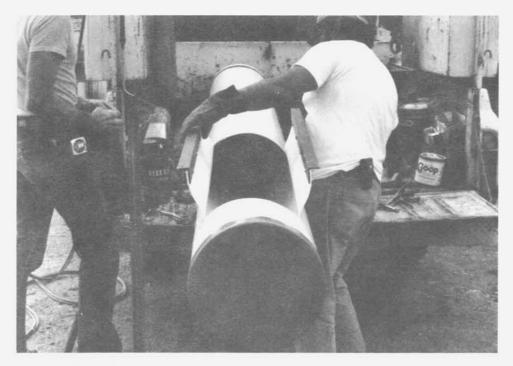
Figure 5. Shaping the trough and attaching angle iron supports.

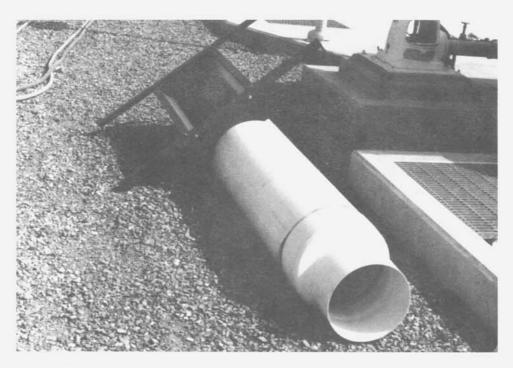
Figure 6. PVC pipe and opening for entry of wash water and moss.

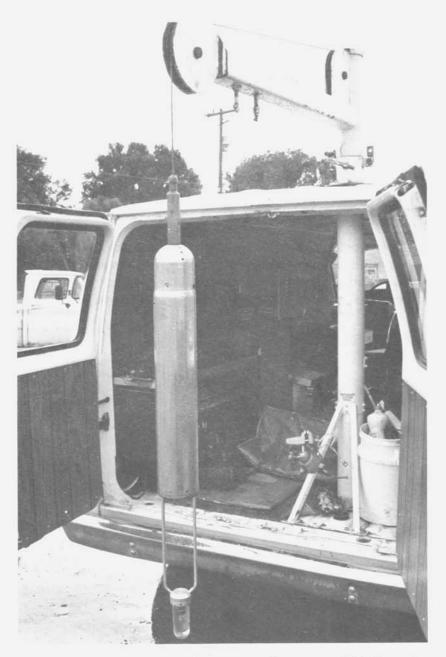
Figure 14. Once the van is backed up to a well, camera and light (located in front of lens tube) are lowered with this L-boom and winch.

All of Cushman's equipment is housed in a modified van. Vehicle changes include an L-arm to pivot the camera over the well and play out the cable, a special alternator system to supply power for the camera and the cable winch, and homemade controls so one man can work the camera cable and monitor the well at the same time.

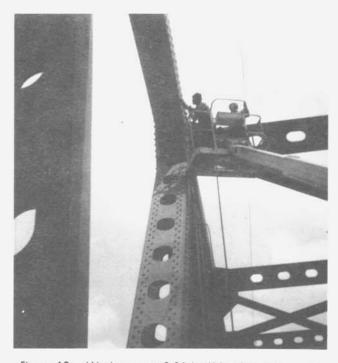
Figure 19. Workmen use 0.31-kg (11-oz) cartridges of caulk to seal voids in prime coat prior to completing bridge painting project.

Since the root of the paint failure and corrosion problem lay in the cavities in the weldments, the highway engineers decided to attack the problem by filling them with a permanent sealant. They chose Sikaflex-la caulk, a permanently flexible polyurethane sealant, to cover all exposed seams and produce a smooth, pit-free surface. Sikaflex-la is a product of Sika Chemical Corporation, Lyndhurst, New Jersey.

Although this caulk is usually applied without a primer, the decision was made in this case to use a thin coat of vinyl base primer before gunning on the elastomeric one-part sealer. Primer application, made immediately after sandblasting, protected the steel substrate from
